SUBJECT: Site Inspection, Corporation of the Presiding Bishop, Little Cottonwood Granite Quarry, S/035/017, Salt Lake County, Utah

Date of Inspection: August 6, 2003

M/035/017, Little Cottonwood Granite Quarry, Corporation of the Presiding Bishop

Inspection Dated: August 6, 2003; Report Dated: September 2, 2003

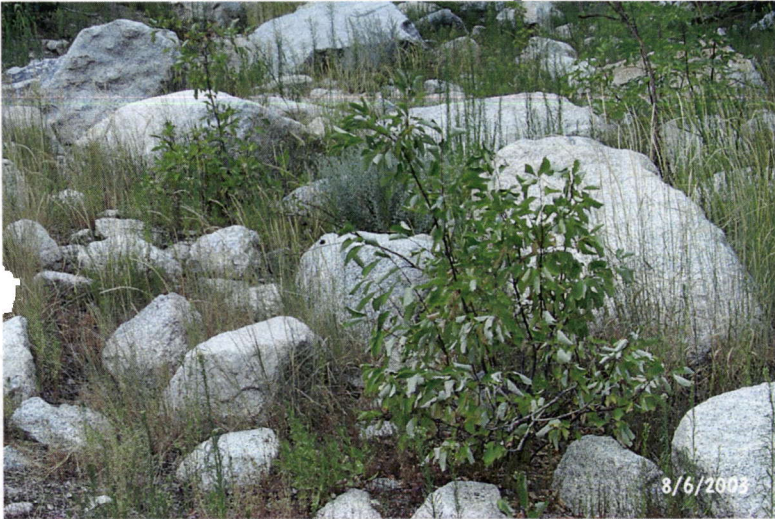
Vegetation is progressing well in the upper part of the reclaimed area (Photos 1 and 2), but there is little perennial vegetation in lower areas (Photo 3). Most of the plants in Photo 3 are horseweed. The upper part also has more rock on the surface and several shrubs coming from between the rocks. The shrubs include elderberry, big tooth maple, big sage, and chokecherry.

Photo 1. Chokecherry, elderberry, big sage, and other perennial vegetation in the upper part of the reclaimed area.

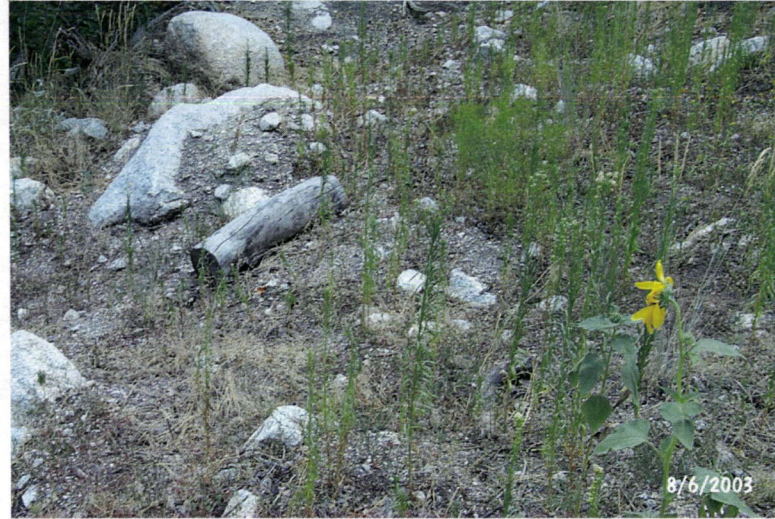
Photo 3. Vegetation in the lower part of the reclaimed area. Note the lack of rocks compared to photos 1 and 2. Most of the plants in this photo are horseweed (*Conyza canadensis*).

I believe the operator should reseed the lower part of the disturbed area. With adequate precipitation, it should be possible for substantially more perennial vegetation to become established in this area in a short time.

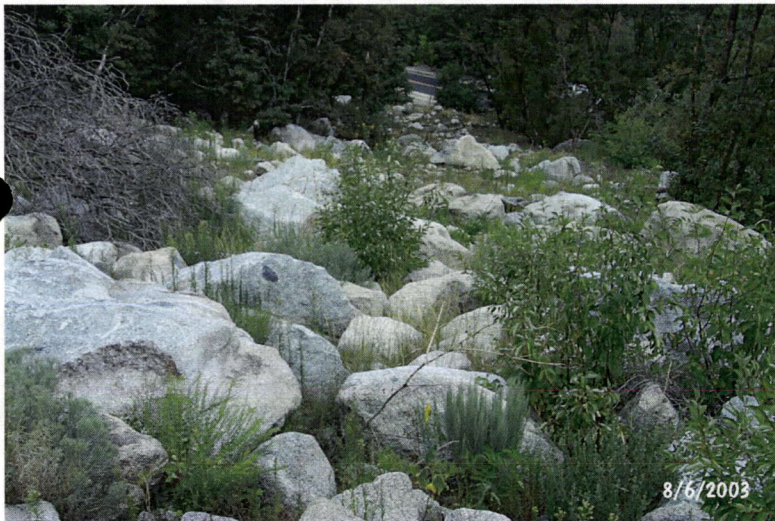
Photo 2. Another view of the upper portion of the reclaimed area.
